LOC PRELIMINARY WALKOVER SURVEY RECORD SHEET
MOAI ON THE ARA MOAI

Moai no: <u>RR-117</u>		Site Name: <u>Ams</u>		Associated Feature Nos: <u>NONE</u>	
AMS <u>102</u>		Previously noted (tick) <input checked="" type="checkbox"/>		Atlas: <u>RR-117</u>	
Easting: <u>0669451</u>		Northing: <u>6998251</u>			
Statue height: <u>7.9 m</u>		Statue width (across girth): <u>2.2m</u>		Statue thickness (from back to front at girth): <u>> 1.2m</u>	
Photo Nos (yes/no):					
Land use: <u>scrub</u>			Physical relationships: <u>NONE</u>		
Position of statue(tick):			Supine	Prone <input checked="" type="checkbox"/>	On left side
Description/interpretation: <u>WHOLE MEDIUM SIZED MOAI WITH HEAD POINTING DOWNSLOPE AWAY FROM RANO KARAKU DEEPLY BURIED AT HEAD END</u>					
Orientation of long axis of statue:

Moai no: AMS 103	Site Name: ARA MOAI	Associated Feature Nos: NONE		
Previously noted (tick) ✓	Atlas: 13-477	Hunt:	Shepardson:	Other: HEYERDAHL
Easting: 0669436		Northing: 6998230		
Statue height: 7.8m		Statue width (across girth ^{base}): 2.4m	Statue thickness (from back to front at girth): 2m	
Photo Nos (yes/no):				
Land use: ROUGH SCRUB		Physical relationships: NONE		
Position of statue(tick): S N		Su

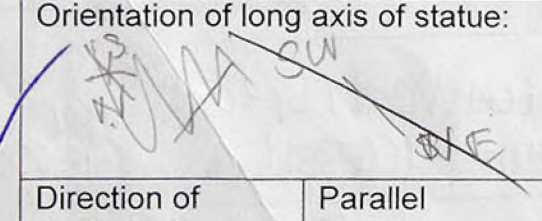
Declination of long axis of statue: <u>10°</u> <u>Head on downslope</u>		Alignment with Ara Moai: <u>parallel with path</u>	
Direction of geological bedding with relation to the statue's longitudinal axis (tick)	Parallel	Horizontal	At angle <input checked="" type="checkbox"/>

FRONTAL WEATHERING

L	R
UPPER EYE	N/VIS	N/VIS
BOTTOM EYE/CHEEK	N/VIS	N/VIS
LOWER CHIN/NECK	N/VIS	L
CHEST	N/VIS	N/VIS
STOMACH/HANDS	N/VIS	LIGHT

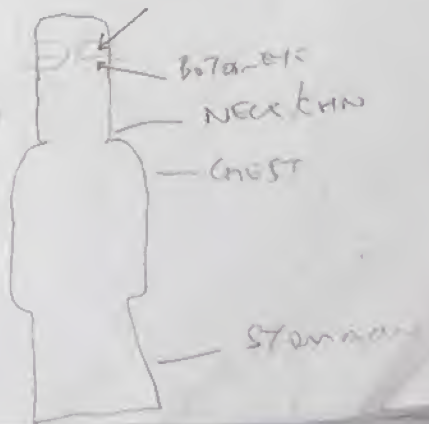
quite a bit of L.H.
are likely to fall off soon

IMMINENT COLLAPSE

L.H. side
top of head - heavily weathered
base of head - moderately
chest - moderately
stomach - heavily
base of chest - moderately

R.H. side
top of head - heavily weathered
base of head - heavily
chest - moderately
stomach - moderately
base of chest - moderately

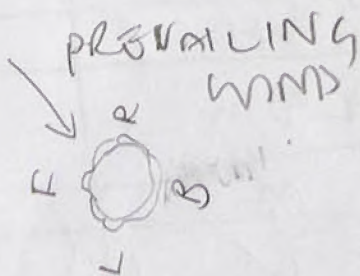
AMS 116

MORE
WEATHERED
LIGHT
FRONT

HEAVY
AS OPPOSED

TO
MODERATE
LEFT
CHEST
